Mawgan Porth - Flooding Report

Flood Event Date: 25 March 2024

Report Date: June 2024

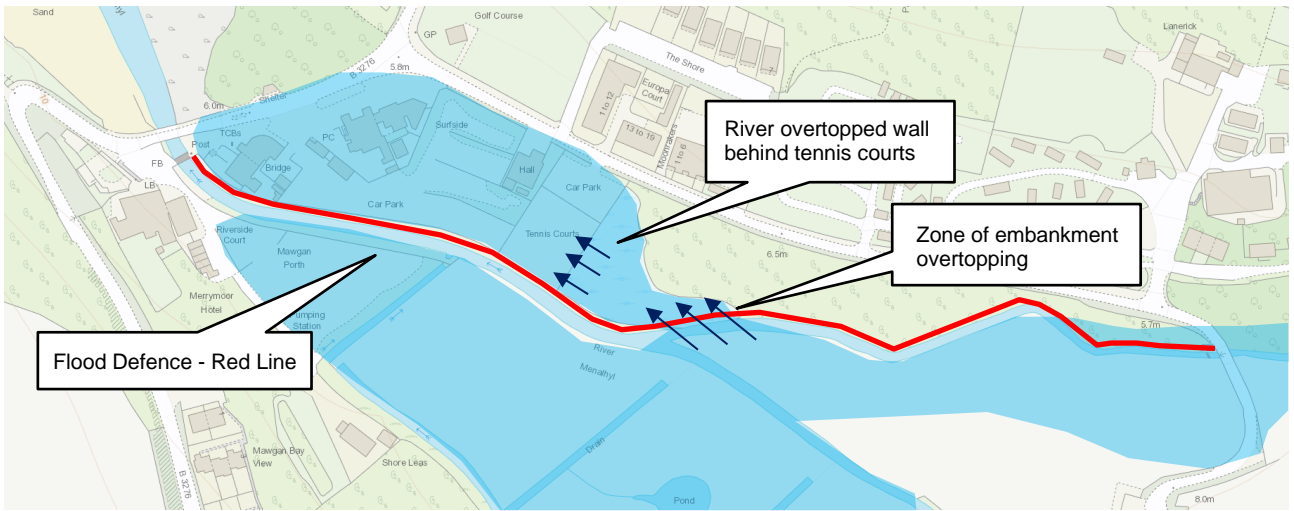
Information provided by residents and topographic levels taken, indicate that peak flood water levels were generally around 300mm higher than the crest levels of the low wall to the rear of the tennis courts by the Village Hall. This suggests that the floodwaters overtopped the flood defence embankment at the zone of confluence of the Gluvian Stream and River Menalhyl, and then overtopped the low wall by the tennis courts, before flowing down into the built-up area causing the flooding. Level surveys conducted by the Environment Agency after the flood event appear to suggest this mechanism of the flooding.

Figure 1 - Perceived extent and mechanism of flooding based on witness observations and site evidence / surveys

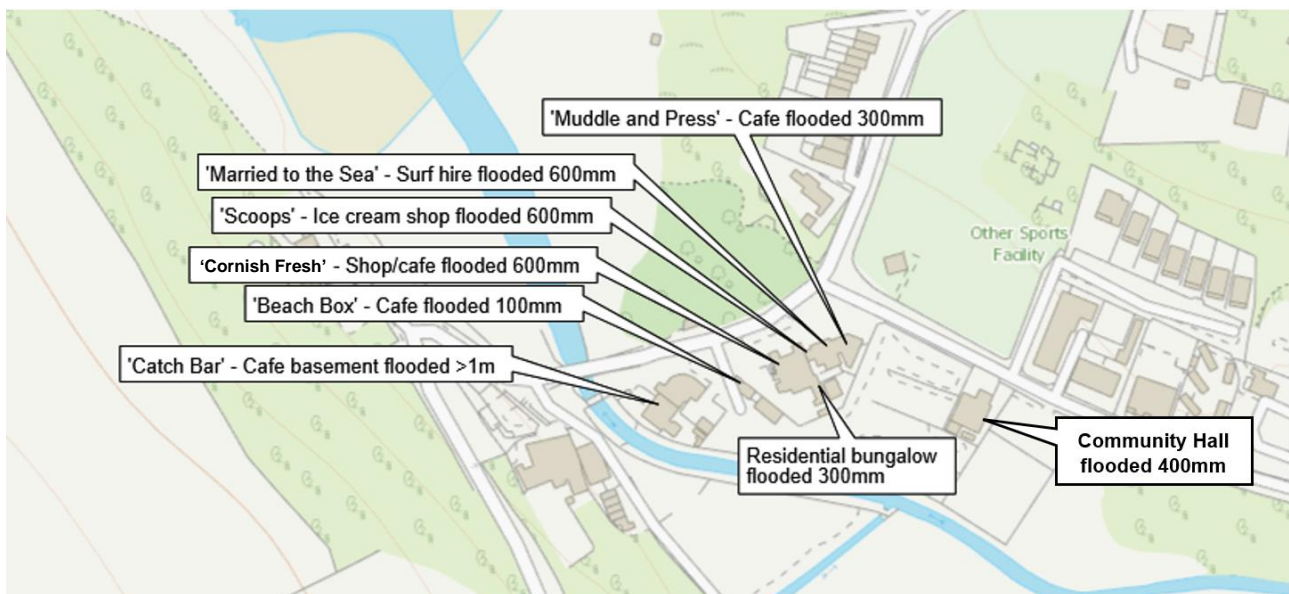
A total of 8 built properties were reported as flooded to the following approximate depths:

- 'Catch Bar' - Café by bridge had its basement flooded >1m deep (the north-easterly adjacent property is raised and is not reported to have flooded)
- 'Beach Box' - café flooded 100mm
- 'Cornish Fresh' - Shop/café flooded to 600mm
- 'Scoops' - Ice cream shop flooded to 600mm
- 'Married to the Sea' - Surf hire shop flooded to 600mm
- 'Muddle and Press' - Café flooded to 300mm
- Residential bungalow flooded to 300mm
- Community Hall flooded to 400mm
- Some containers and a temporary food stand were flooded to approximately 100mm

Figure 2 - Map showing reported flooded properties

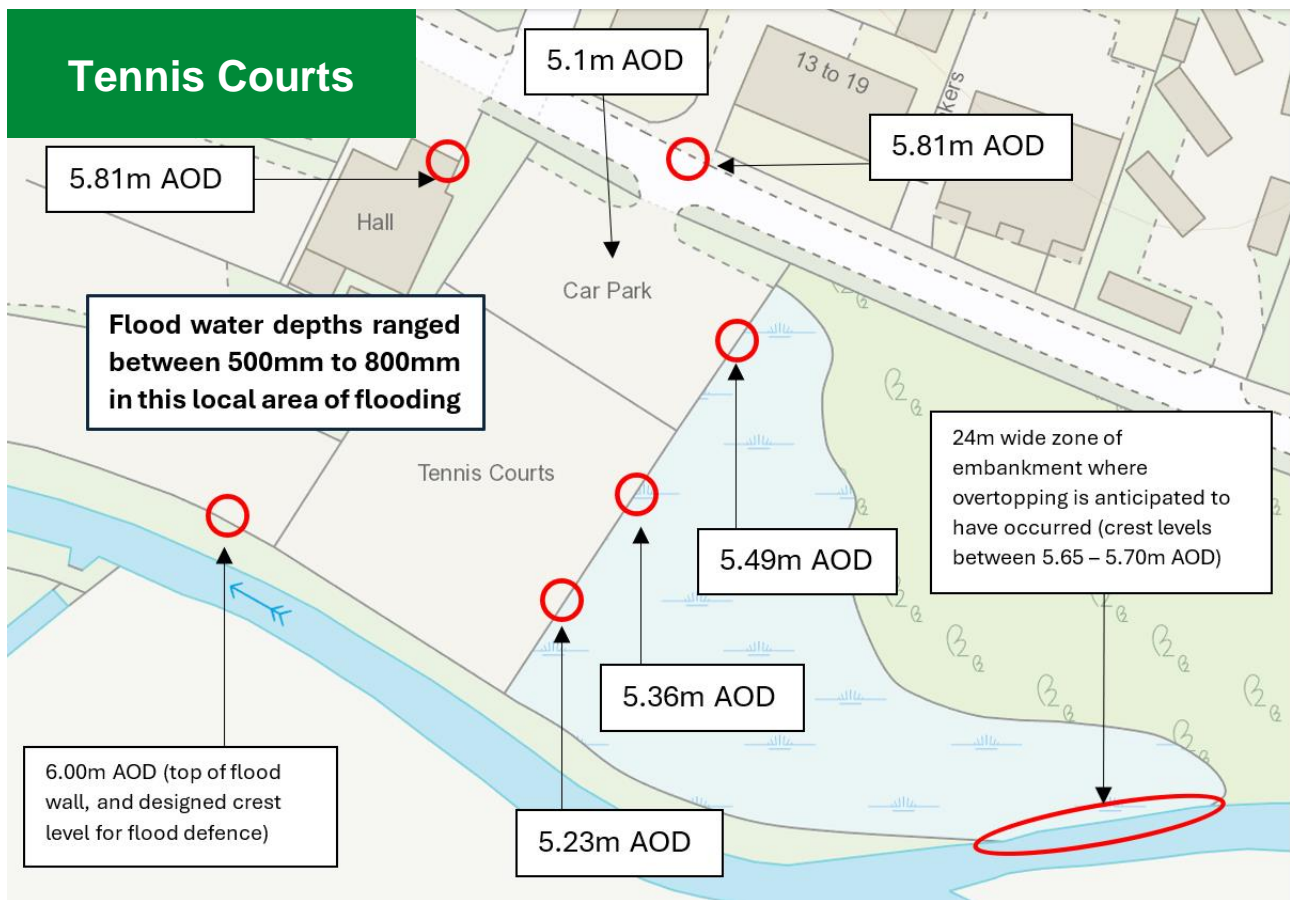
Figure 3 - Recorded ground levels with estimated flood depths in vicinity of Tennis Courts.

All ground levels detailed within Figure 3 were calculated through a Level Survey, using an optical level and levelling staff. However, it should be noted that the recorded elevations (5.65 – 5.70m AOD) for the referenced '24m wide zone of embankment where overtopping is anticipated to have occurred' was recorded via a Lidar Survey (Digital Terrain Modelling).

This type of remote digital terrain data has the potential for a greater margin of error. However, the day after the flooding occurred, an Environment Agency Asset Management team undertook a reconnaissance of Mawgan Porth and photographed this section of the embankment. Evidence of substantial 'rack marks' (toppled and tilted vegetation caused by the recent flood event) was identified both atop and on the landward side of the embankment. We consider that this site-based evidence has further verified the zone of embankment overtopping and has also validated the accuracy of the lidar data in this case.

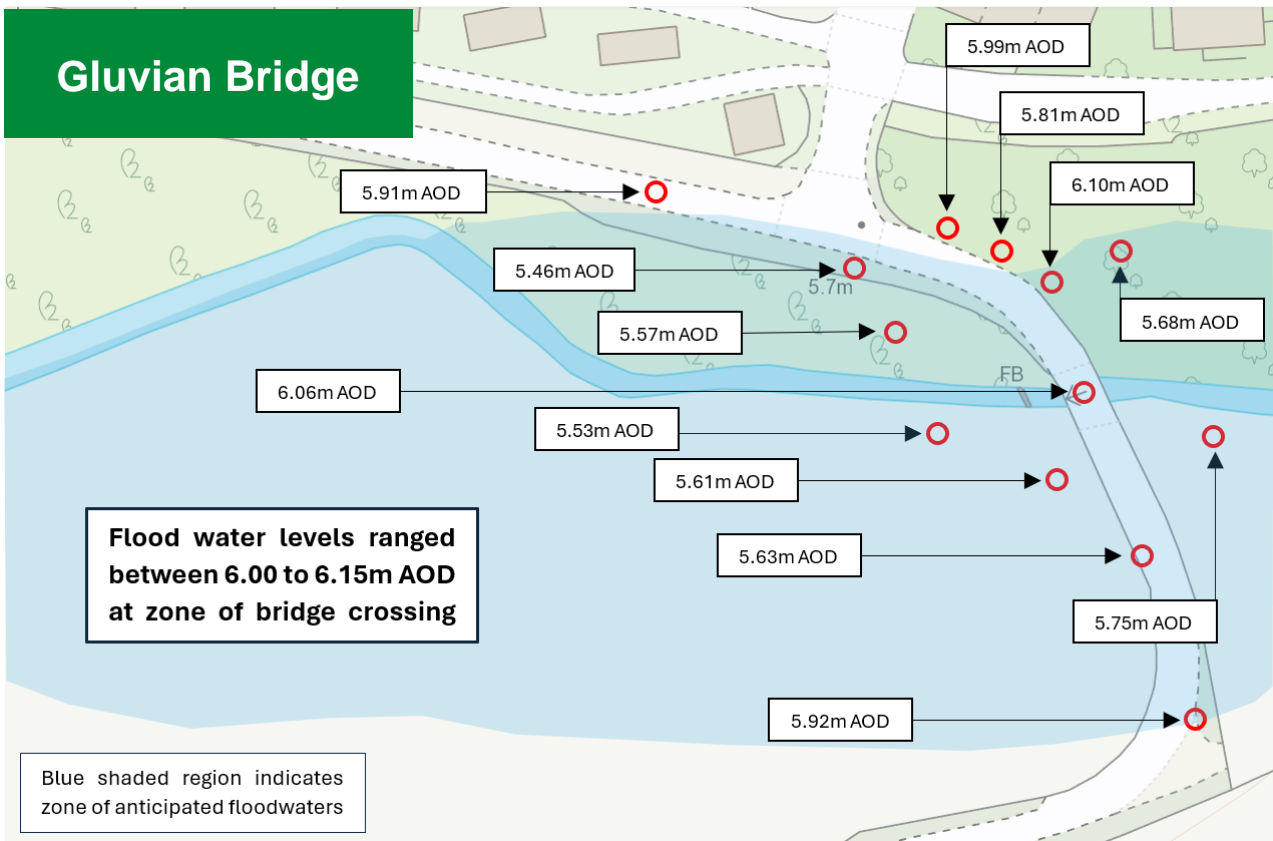
Figure 4 - Recorded ground levels with estimated flood extent in vicinity of Gluvian Bridge

Spot-point elevations taken during our level survey along the northerly adjacent road do appear to indicate that it would be possible for high river flows (between 6.00 to 6.15m AOD) to overtop the Gluvian Bridge and pass down this northerly adjacent road. However, we believe that the large volume of flood-water storage available on the southern side of the river, and the comparably lower elevation terrain, means that the vast proportion of the out-of-bank flows would have preferentially entered the southerly adjacent fields, instead of this road. This was further evidenced on-site by tall 'rack marks' and piled vegetation, indicating a significant depth of flooding occurred in the southern fields. Such evidence was not found along the road, reducing the likelihood that the road would have acted as a substantial flow-route pathway. The photographic evidence available also appears to support this theory.
